Debris/Ice/TPS Assessment and Integrated Photographic Analysis of Shuttle Mission STS-89

**DEBRIS/ICE/TPS ASSESSMENT
AND
INTEGRATED PHOTOGRAPHIC ANALYSIS
OF
SHUTTLE MISSION STS-89**

22 January 1998

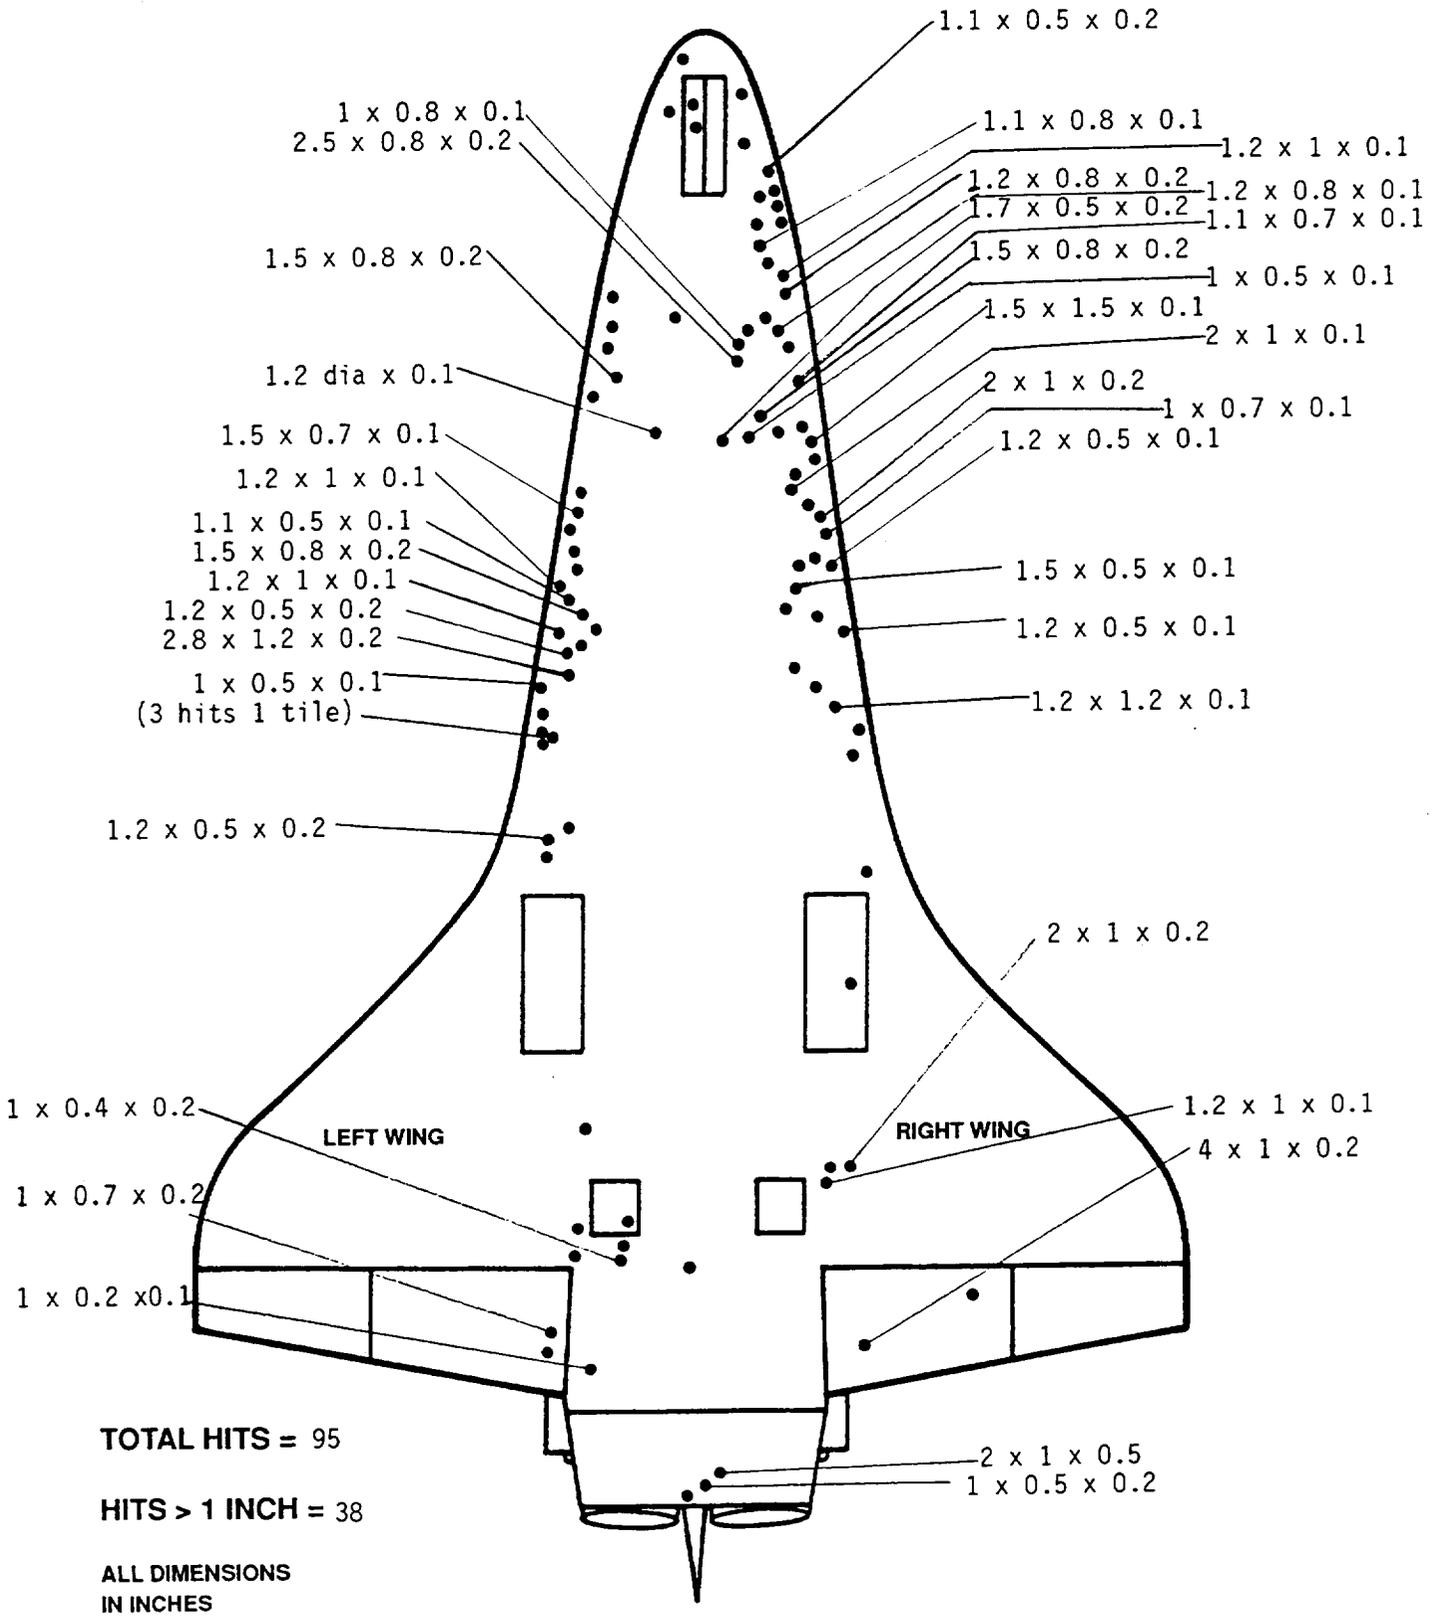
Figure 1: Orbiter Lower Surface Debris Damage Map

The Orbiter lower surface sustained 95 total hits, of which 38 had a major dimension of 1-inch or larger. Most of this damage was concentrated near the outboard edges in a line generally running from the nose landing gear to the main landing gear. These damage sites follow the same location pattern documented on STS-86 and STS-87. Although the numbers were greater than the fleet averages for the lower surface, it should be noted that the quantity, sizes, and depths of the damage sites were substantially less than that of STS-87. No lower surface tiles were scrapped due to debris impact damage.

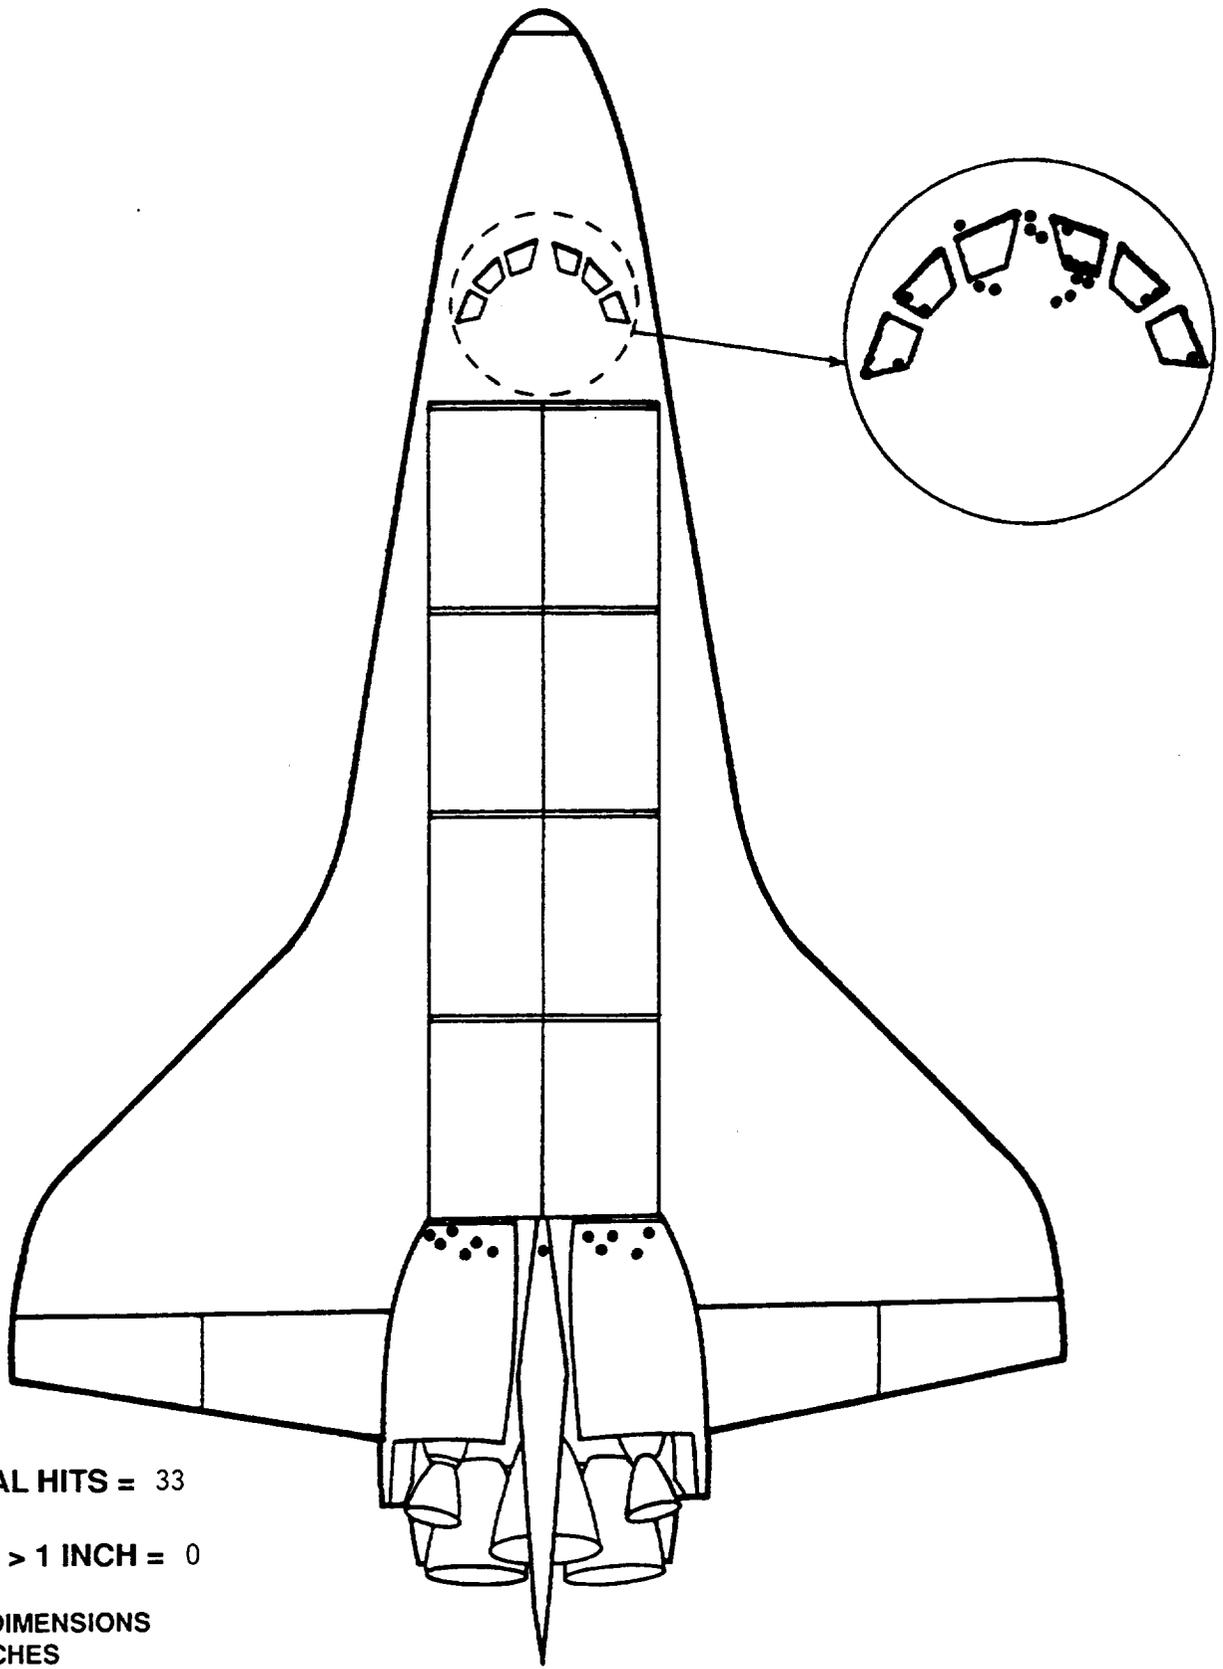
Figure 4: Orbiter Upper Surface Debris Damage Map

TOTAL HITS = 33

HITS > 1 INCH = 0
